Errata

MSP430FG438 Microcontroller

This document describes the known exceptions to the functional specifications (advisories).

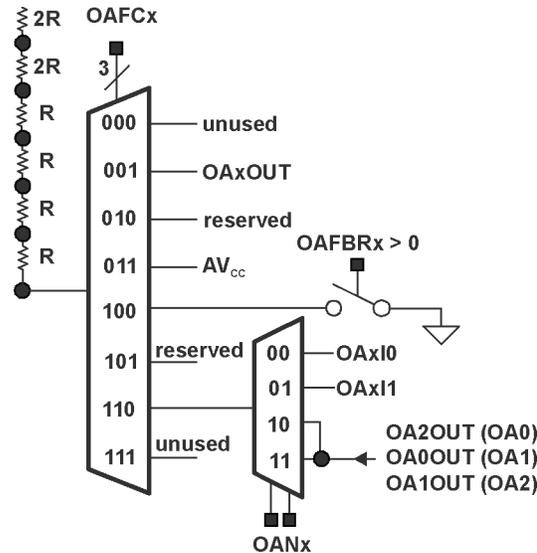
OA1

Function OAxI1 input selection

Description Referring to the OA block diagram in the MSP430x4xx User's Guide, the internal connection of the OAxI1 input to the OAFcX mux is incorrect. The signal input to the OAFcX mux when OANx = 01 is OA0I1 for all OAs. See the figure below for a graphical representation.

Workaround None
