Active Errata List

CAN Microcontrollers

T89C51CC01
T89C51CC01UA
T89C51CC01CA

Errata Sheet

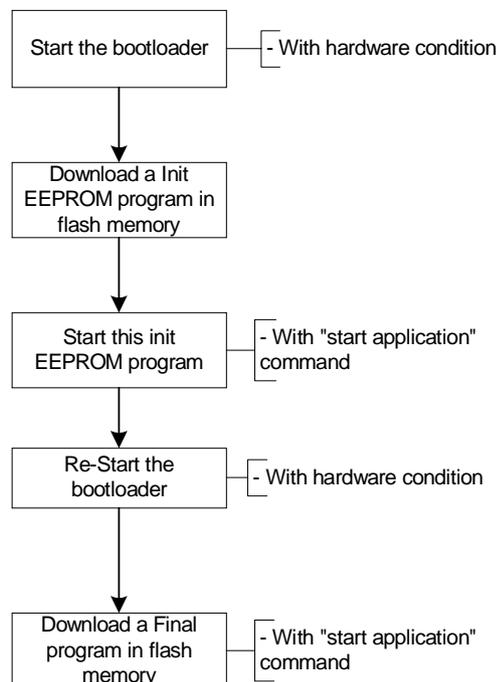
16. EEPROM – Lock-up during ISP write

Program lock-up can be experienced when using Atmel FLIP software or a custom In system Pogramming tools to write in the internal EEPROM. This problem occurs with clock frequency > 12MHz in X2 mode or 24MHz in X1 mode. Neither the code Flash nor the EEPROM are corrupted by the lock-up. Although the EEPROM cannot be written by the bootloader.

This problem is bootloader related and doesn't affect the capability for the user to read and write into the EEPROM. This problem is technology dependant. The likelihood of experiencing the problem is low at Clock frequency > 24 MHz in X1 mode and non-existent below. A reset can be applied to recover from the lock-up.

Workaround

The following process can be done to work around the problem.

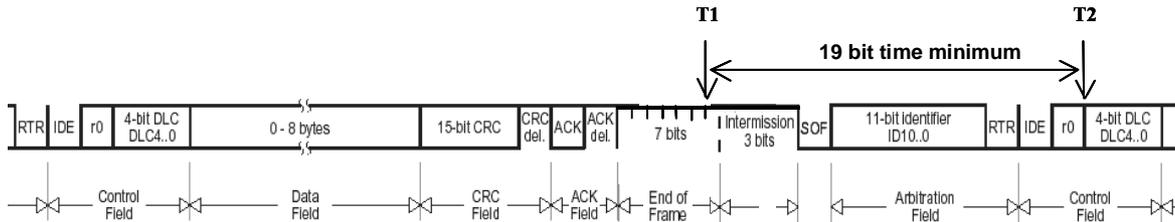
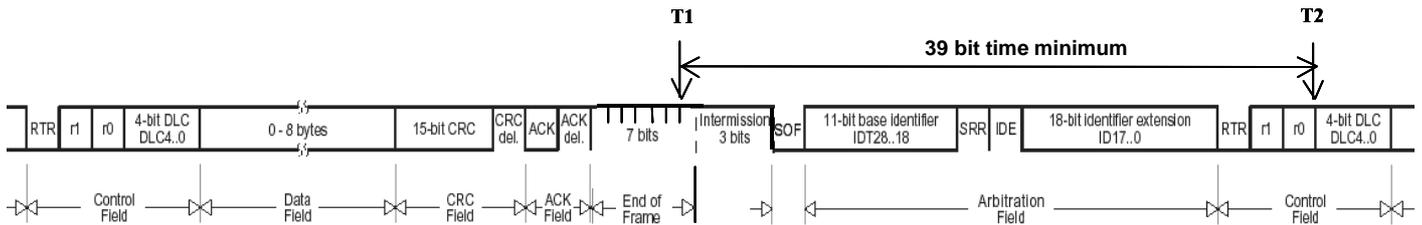
17. Transmission after a 3 bit Intermessage

If a Transmit Message Object (MOB) is enabled while the CAN bus is busy with an on going message, the transmitter will wait for the 3-bit Intermission before starting its transmission. This is in full agreement with the CAN recommendation.

If the transmitter lost arbitration against another node, two conditions can occur :

1. At least one Receive MOB of the chip are programmed to accept the incoming message. In this case, the transmitter will wait for the next 3-bit Intermission to retry its transmission.
2. No Receive MOB of the chip are programmed to accept the incoming message. In this case the transmitter will wait for a 4-bit Intermission to retry its transmission. In this case, any other CAN nodes ready to transmit after a 3-bit Intermission will start transmit before the chip transmitter, even if their messages have lower priority IDs.

Workaround

Always have a Receive MOB enabled ready to accept any incoming messages. Thanks to the implementation of the CAN interface, a Receive MOB must be enable at latest, before the 1st bit of the DLC field. The Receive MOB status register is written (RXOK if message OK) immediately after the 6th bit of the End of Frame field. This will leave in CAN2.0A mode a minimum 19-bit time delay to respond to the end of message interrupt (RXOK) and re-enable the Receive MOB before the start of the DLC field of the next incoming message. This minimum delay will be 39-bit time in CAN2.0B. See CAN2.0A CAN2.0B frame timings below.

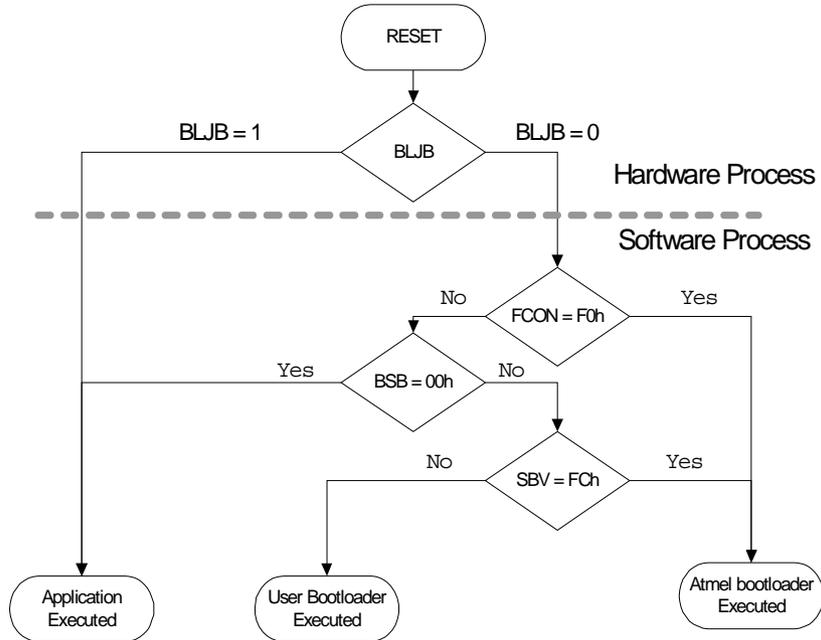
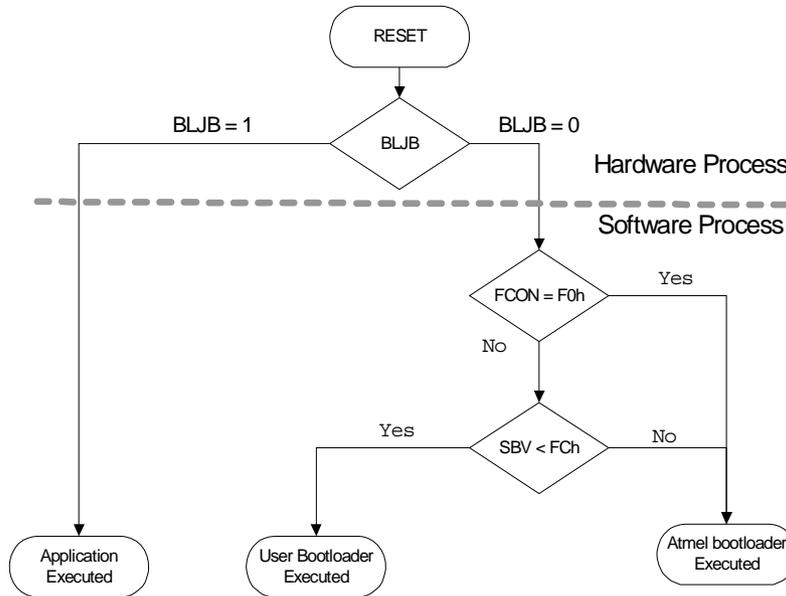
4. Boot Process Compatibility

There are some differences between Boot process of bootloader 1.2 and newer versions (see below).

Workaround

Use the fuse bit BLJB to start the application in both versions.
